Manhole Inspection Summary

Manhole # S19A__037MH

Location Address: **2022 LANVALE ST**

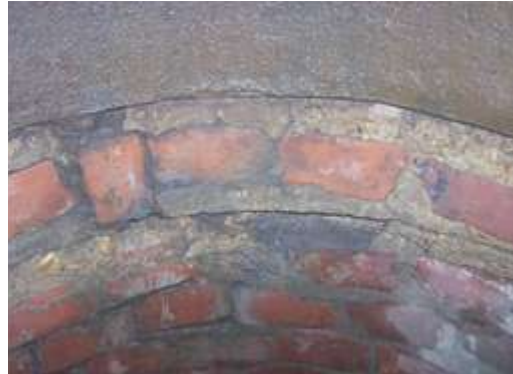
Defect 3

Corbel Material: **Brick** ☐ Parged Type: **Concentric/Eccentric**

Condition: ☐ Sound ☐ Cracked ☐ Root Intrusion ☐ Loose Brick ☒ **Deteriorated**

Infiltration: ☐ None ☐ Joint ☐ Cracks ☐ Mortar ☐ Roots ☒ **Wall**

CORBEL DETERIORATION AND INFILTRATION OF THE CORBEL WALL

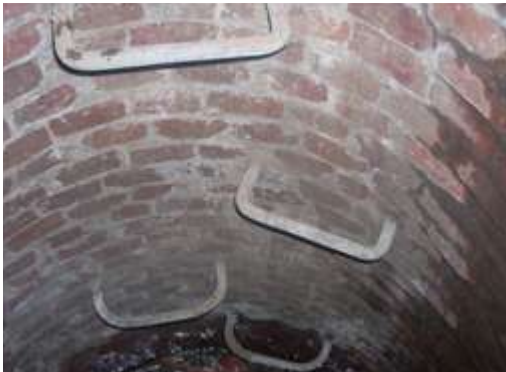
Defect 4

Infiltration: ☐ None ☐ Joint ☐ Cracks ☐ Mortar ☐ Roots ☒ **Wall**

BARREL WALL INFILTRATION AT THE BOTTOM OF THE PICTURE

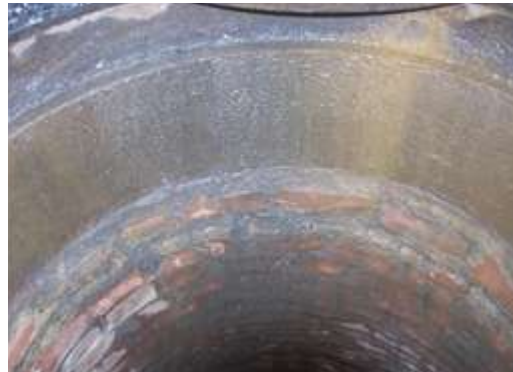
Defect 2

Infiltration: ☐ None ☒ **Joint** ☐ Cracks ☐ Mortar ☐ Roots ☐ Wall

CHIMNEY JOINT INFILTRATION

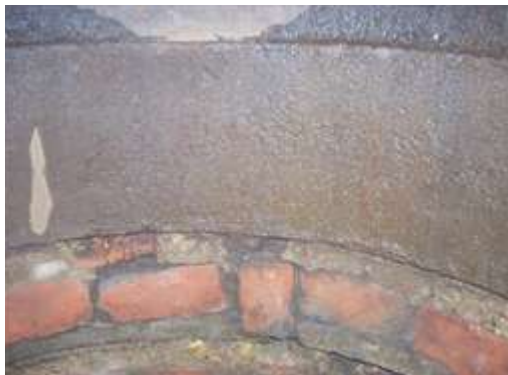
Defect 1

Condition: ☐ Sound ☐ Cracked ☐ Root Intrusion ☐ Loose Brick ☒ **Deteriorated**

DETERIORATED CHIMNEY

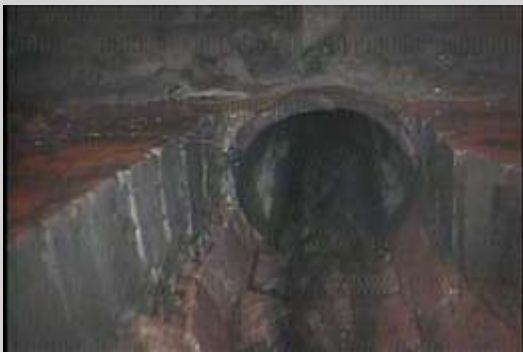
12 O'Clock Outflow

8 in. Circular Gravity Sewer
Pipe Out @ 12 O'Clock

Pipe Height: **8.4** (in.) Rod and Bar (Angled)
Pipe Material: **Clay** ☐ Pipe Lined
Invert Depth: **7.92** (ft.) Flow Characteristics: **Slow**
Deposits: ☒ None ☐ Mud ☐ Sludge ☐ Debris ☐ Grease
Silt Depth: (in.) Deposits Extent:
Infiltration: **None** Pipe Seal Cond: **Sound**

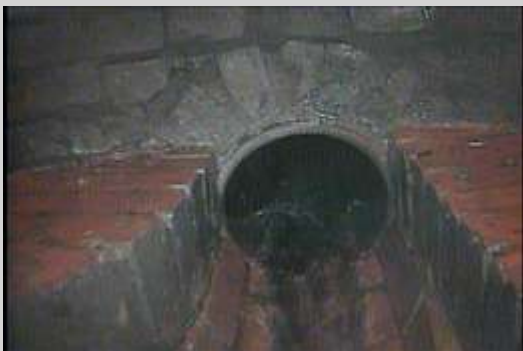
3 O'Clock Inflow

8 in. Circular Gravity Sewer
Pipe In @ 3 O'Clock

Pipe Height: **7.2** (in.) Rod and Bar (Angled)
Pipe Material: **Clay** ☐ Pipe Lined
Invert Depth: **7.79** (ft.) Flow Characteristics: **Slow**
Deposits: ☒ None ☐ Mud ☐ Sludge ☐ Debris ☐ Grease
Silt Depth: (in.) Deposits Extent:
Infiltration: **None** Pipe Seal Cond: **Sound**
